The
LaQUE CENTER
FOR CORROSION TECHNOLOGY, INC.

**SEAWATER CREVICE CORROSION RESISTANCE OF
STAINLESS STEELS COATED WITH
SILANE AND ANTIFOULING PAINT SYSTEMS**

**FINAL REPORT
CONTRACT N00014-01-C-0177**

August 2002

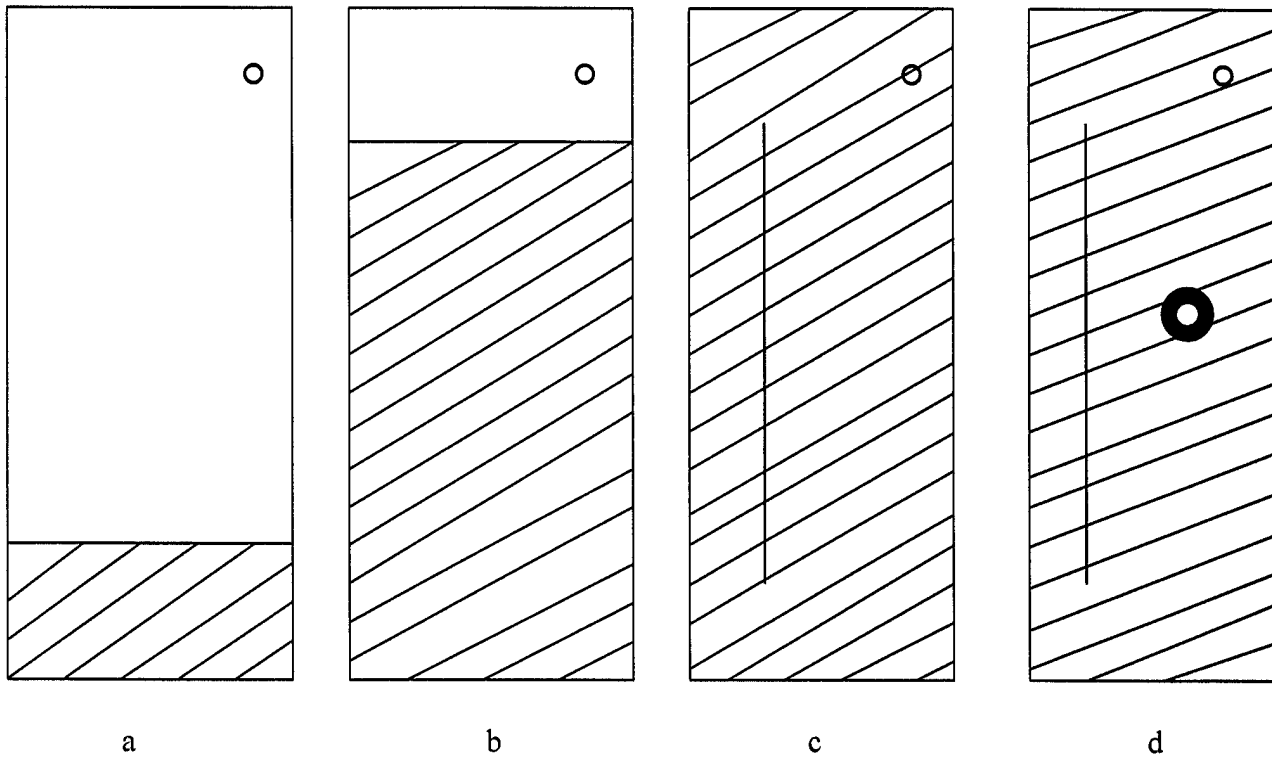
FIGURE 1- Schematic representation of various coated specimens tested.
a – 20% coverage with epoxy, or silane, or silane + ablative Cu
b – 80% coverage as for Type a
c – 100% coverage with silane + ablative Cu and scribed
d – 100% coverage as for Type c with Zn anodes attached

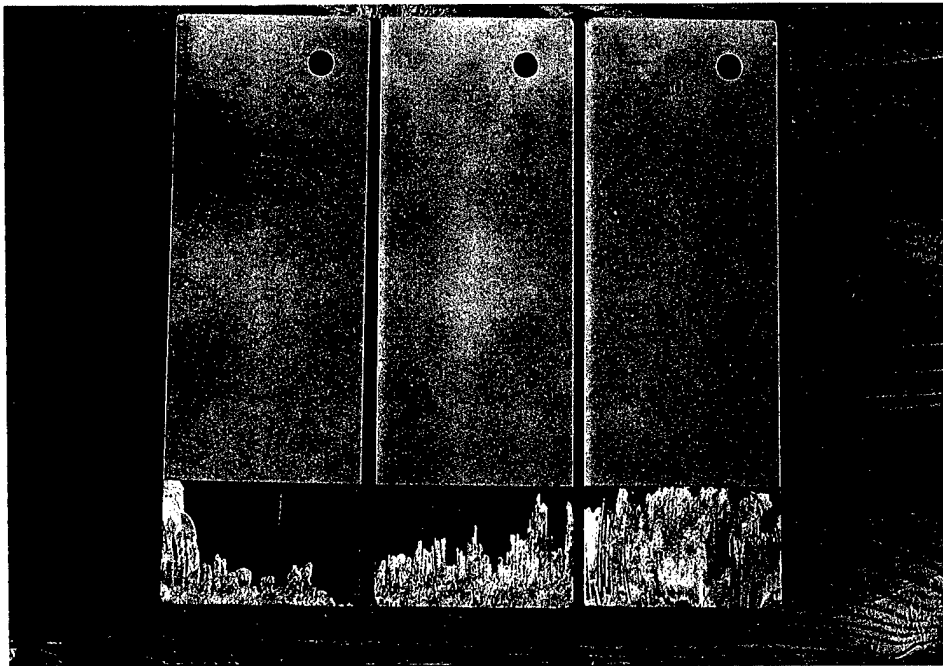
All S31603 specimens with 20% of the surfaces coated with silane + ablative Cu exhibited crevice-like attack. However, in contrast to the epoxy coated controls, the attack appeared to propagate inward from the edges and other initiation sites rather than from the primary interface with the bare metal. As shown by Figure 6, some influence of silane formulation on the overall extent of attack is apparent from the visual ranking $A < B < C$. Except for attack at apparent pit initiation sites, the attack beneath the silane + ablative Cu was relatively light, as contrasted with that found beneath the epoxy.

FIGURE 6 – After-cleaning view of S31603 specimens with 20% silane + ablative Cu (left to right: Silane A, B and C precoated)

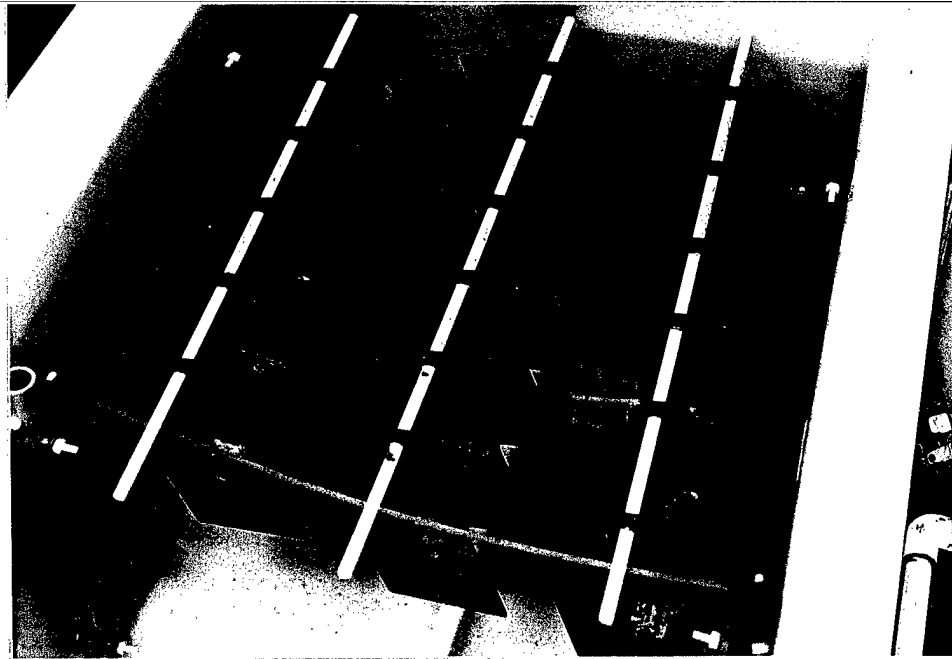
Figure 1.1 2609-04-012-8

Figures 1.1 to 1.3 in Appendix 2 provides a series of photographs showing the in-situ appearance of the specimens remaining in Tanks 3, 4 and 5 for the full nine months. Figures 2.1 and 2.2 document the two affected sites found on the two epoxy coated N08367 specimens described above.

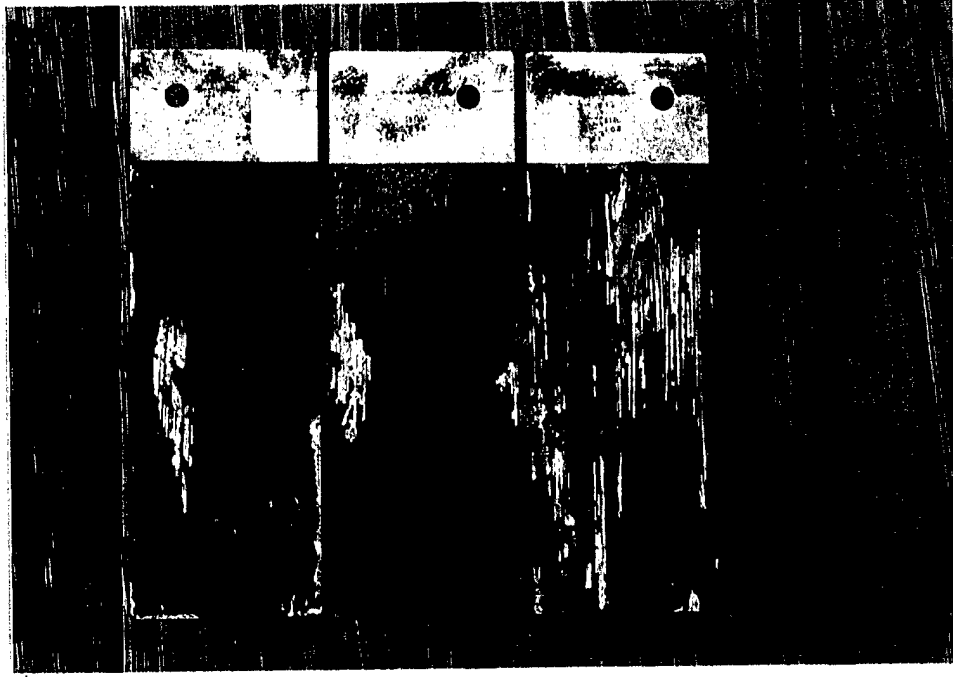
Figure 26.1 2609-04-018-10

S31603 - All 18 partially coated S31603 specimens in both the three-month and nine-month test exhibited some degree of attack. As shown, for example, in Figures 26.1 and 26.2 (worst case example in nine-month test), this attack was largely confined to the coated areas. Unlike those coated with silane alone, attack of the boldly exposed surfaces was minimal, if at all. Figure 26.3 (discussed later) shows the appearance of the corresponding, fully coated + scribed specimen.

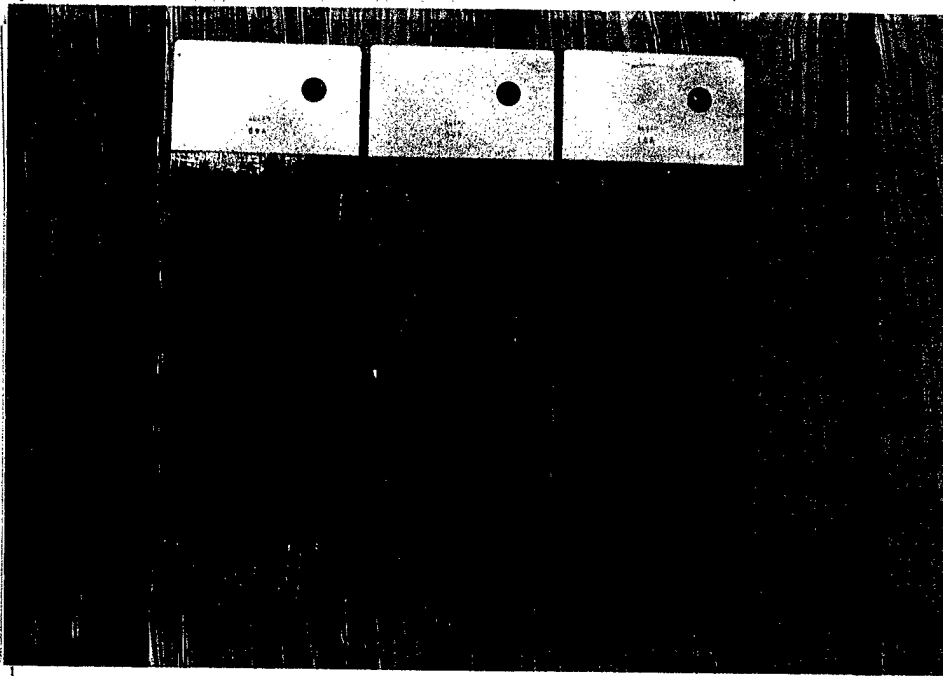
Figure 27.1 2609-04-018-1

specimens were fully resistant to attack in the present nine-month test. Likewise, all 18 in the related three-month test were also fully resistant. Figures 27.1 and 27.2 show the representative appearances of those in the nine-month test. Fully coated + scribed specimens are shown in Figure 27.3.

N08367 - No evidence of corrosion at the scribed defects, or elsewhere, were detected during the final inspection of the nine specimens exposed for each of the two test durations. A representative view of these resistant specimens was shown earlier in Figure 27.3. As shown in Figures 27.1 to 27.3, there was little or no conversion of the antifouling coating to
